UNITED STATES ENVIRONMENTAL PROTECTION AGENCY

Re: EPA RCRA Compliance Inspection
EPA ID# LAD008187080

U.S. ENVIRONMENTAL PROTECTION AGENCY
RESOURCE CONSERVATION & RECOVERY ACT
COMPLIANCE EVALUATION INSPECTION REPORT

Facility Name: **DOW CHEMICAL COMPANY**

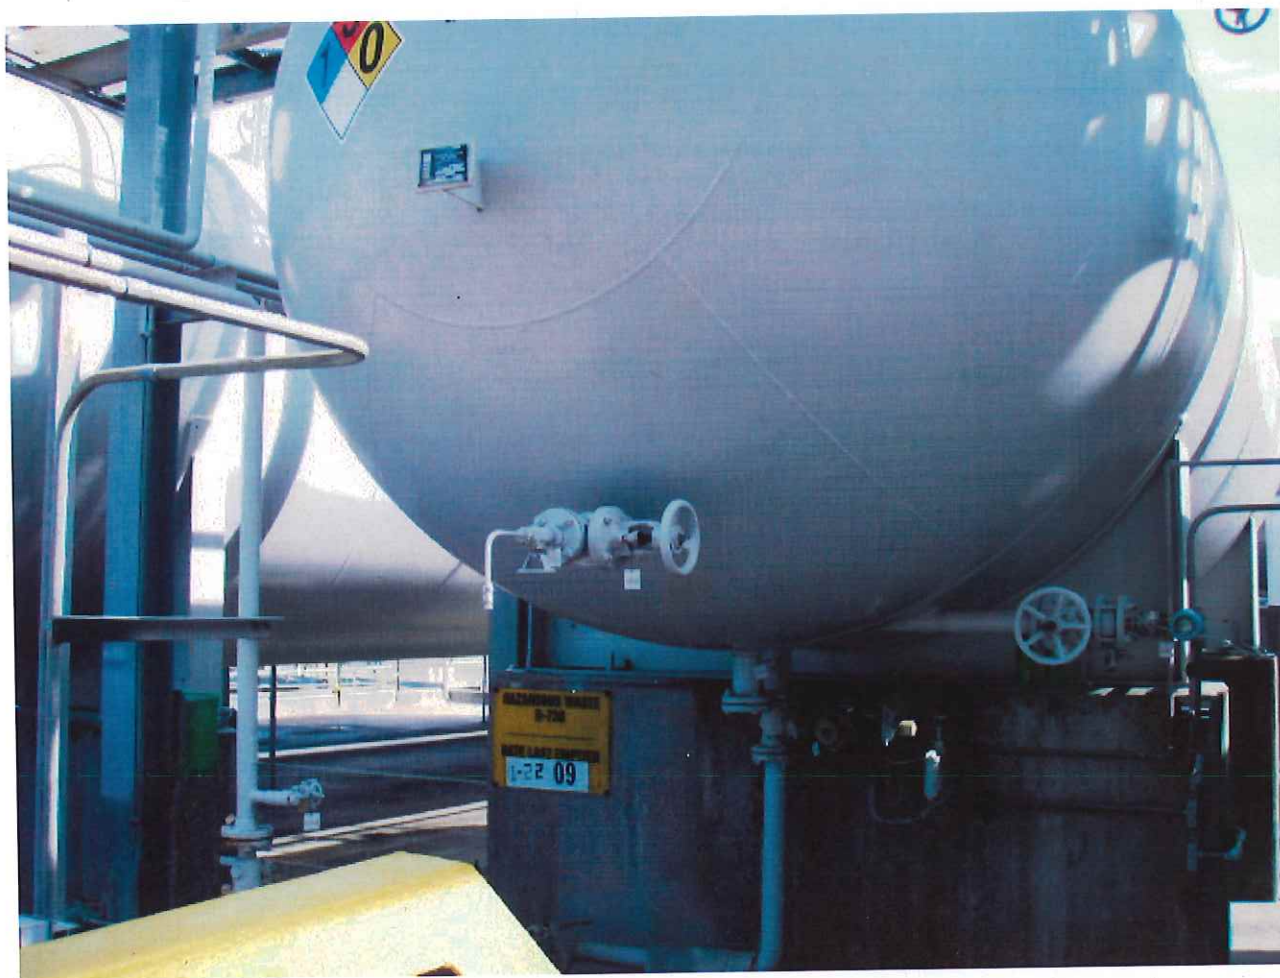
Photo # 1

Photographer: Ryan Rosser	Date: 2/11/09	Time: 1302 Hours
City/County: Plaquemine/ Iberville Parish		State: LA
Location: Dow Chemical Company		
Subject: Above ground hazardous waste storage tank, D-730, located in the facility's Vector Plant. Tank D-730 is a RCRA 90-day tank with a total capacity of 17,000 gallons. According to facility personnel, Tank D-730 holds wastewater, cyclohexane waste, isoprene waste, and isopentane waste.

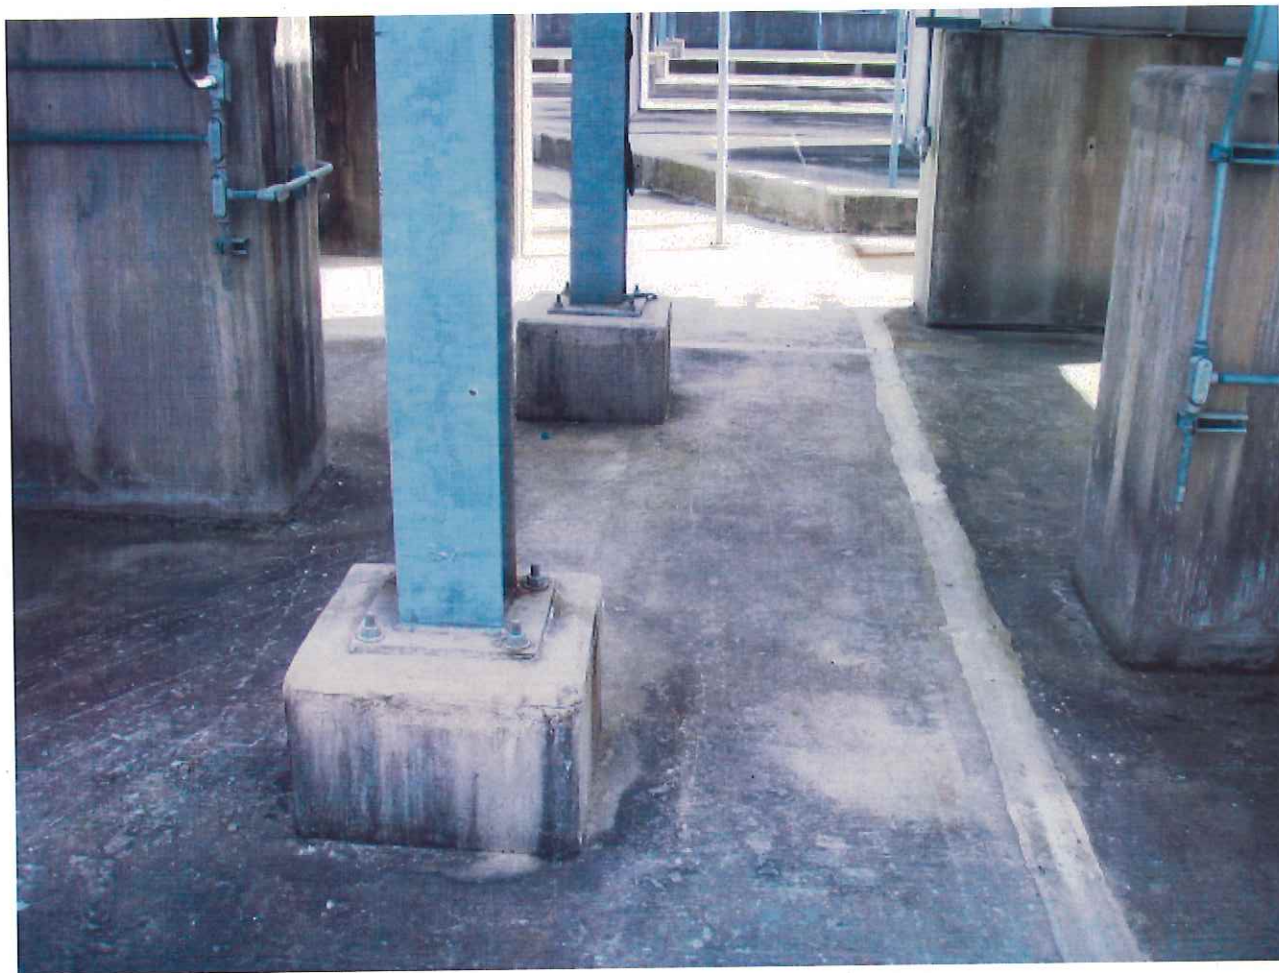
Photo # 2

Photographer: Ryan Rosser	Date: 2/11/09	Time: 1305 Hours
City/County: Plaquemine/ Iberville Parish		State: LA
Location: Dow Chemical Company		
Subject: Secondary containment system flooring for Tank D-730. The secondary containment system is constructed of bare concrete. Hazardous waste tank D-730 shares the secondary containment system with non-RCRA regulated production tanks.

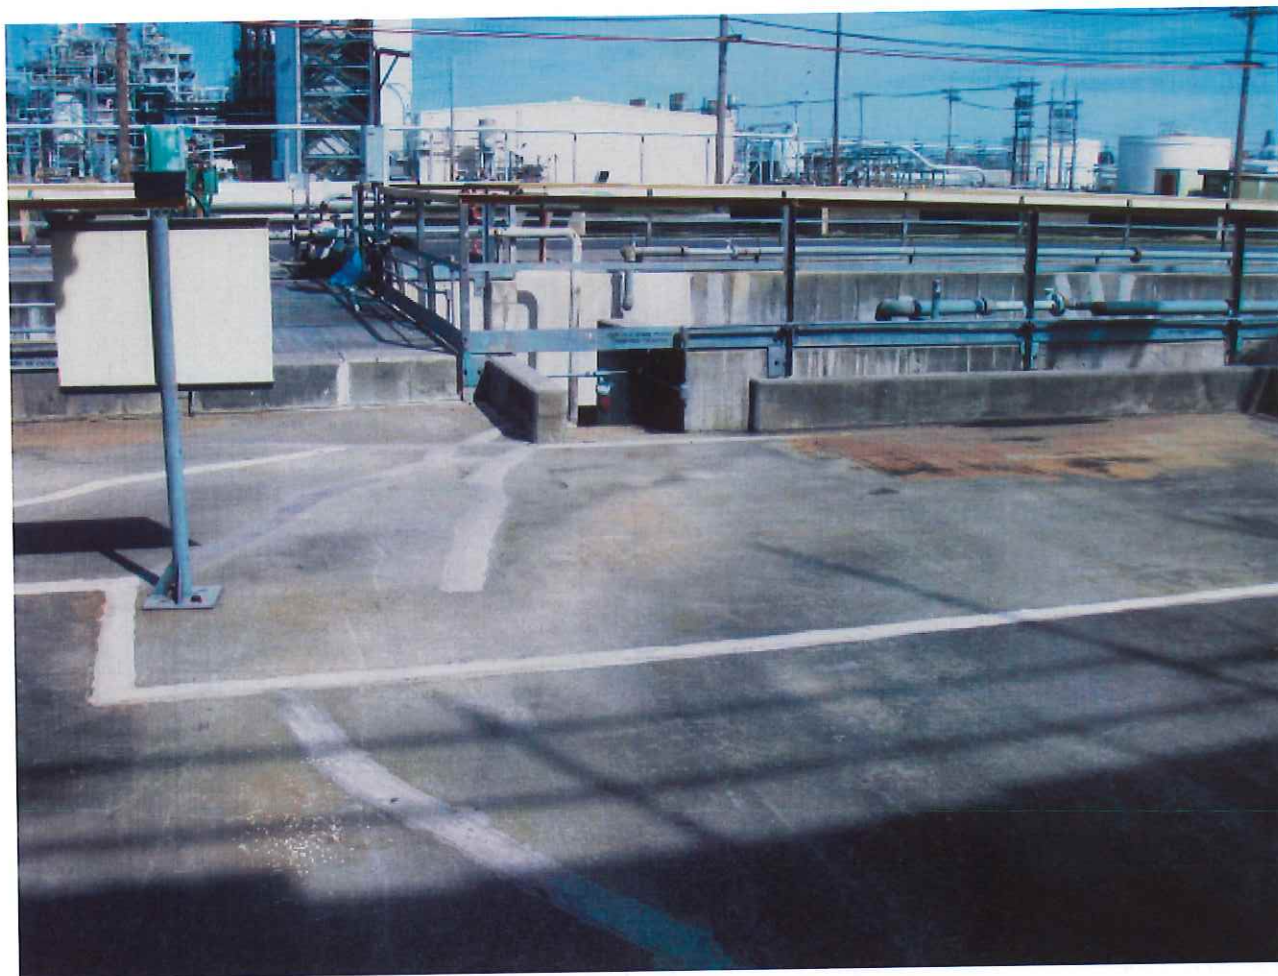
Photo # 3

Upon arriving at the Vector Plant, the EPA Inspector met with additional Dow personnel assigned to the Vector Plant to help provide additional information about the plant's hazardous waste tanks. The EPA Inspector first observed the less-than-90 day tank labeled, D-730 (Photograph #1). Tank D-730 was a horizontal bullet tank raised a few feet above the ground. Dow personnel stated tank D-730 is used to store wastewater, cyclohexane waste, isoprene waste, and isopentane waste and has a total capacity of 17,000 gallons. Tank D-730 was housed with non-RCRA regulated production tanks in the same secondary containment system. The secondary containment system was constructed of bare concrete (Photograph #2). A few cracks in the containment floor were filled in with a material later identified as a silicon elastomer. The material safety data sheet (MSDS) is provided in Attachment C. The EPA Inspector also observed an opening and/or a gap in the containment wall of the secondary containment system for Tank D-730 (Photograph #3). According to Dow personnel, the opening in the containment wall is to allow storm water runoff to empty into a collection system. Dow personnel further stated the runoff in the collection system is sampled prior to any discharges to the division canal. It was unclear whether the collection system was lined.

Photographer: Ryan Rosser	Date: 2/11/09	Time: 1307 Hours
City/County: Plaquemine/ Iberville Parish		State: LA
Location: Dow Chemical Company		
Subject: The secondary containment system for Tank D-730 has an opening and/or gap in the wall. According to facility personnel, the opening/gap in the wall is to allow storm water runoff to empty into a collection system. Facility personnel further stated the collection system is sampled prior to any discharges to the division canal. Note: It is unclear whether or not the collection system is fully lined.

- 2.) During the inspection, the lead EPA Inspector observed a gap in the secondary containment wall for RCRA permitted tank D-730 located in the Vector Plant. Dow personnel stated the gap was used to collect storm water runoff into a collection system. It was unclear to the EPA Inspector whether the collection system was properly lined. According to 40 CFR 265.193(e)(1)(iii) – external liner systems must be free of cracks or gaps.

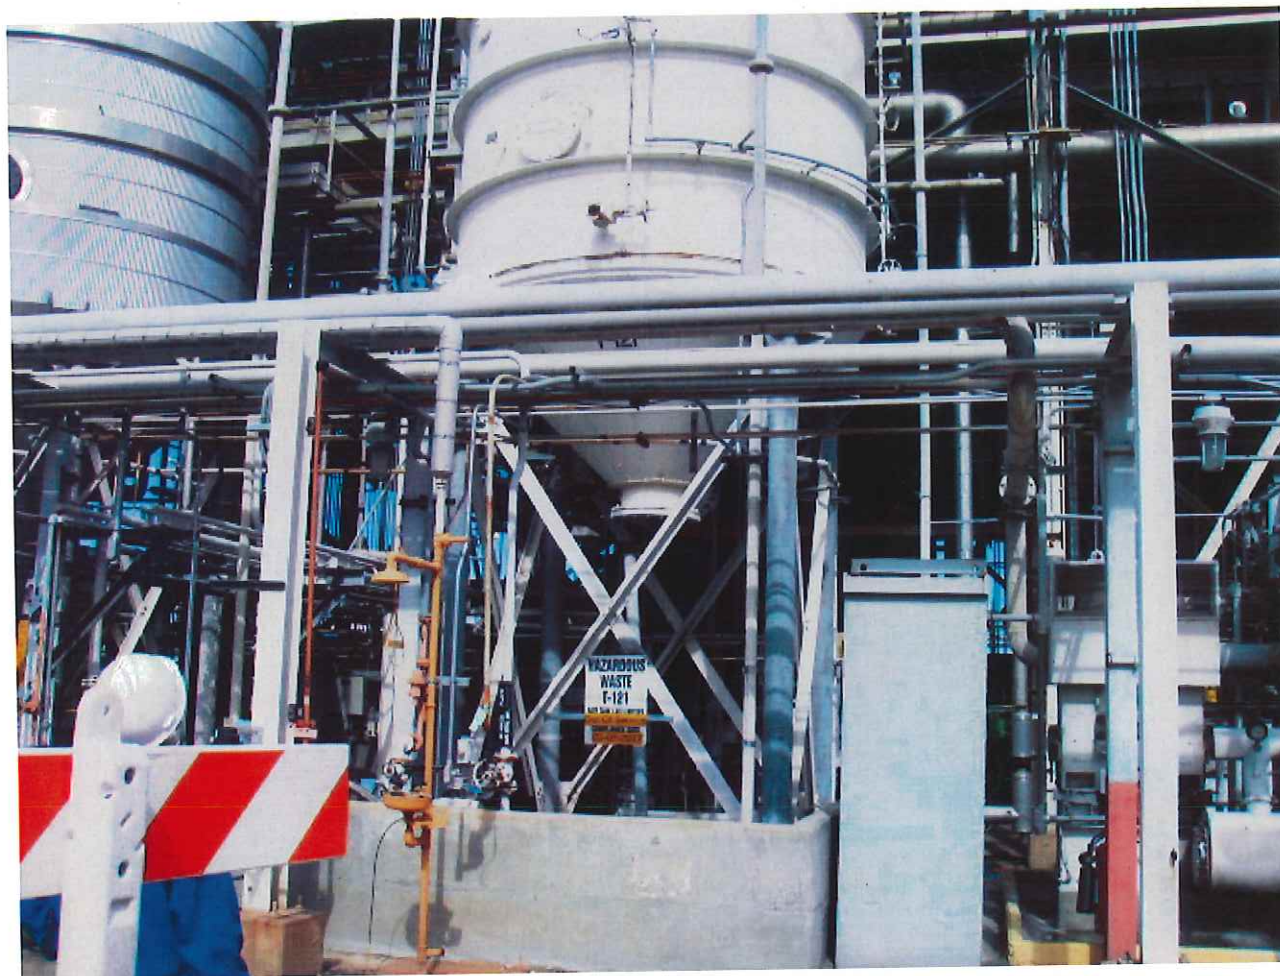
Photo # 4

Photographer: Ryan Rosser	Date: 2/11/09	Time: 1330 Hours
City/County: Plaquemine/ Iberville Parish		State: LA
Location: Dow Chemical Company		
Subject: Above ground hazardous waste tank, T-121 located in the facility's Cellulose Plant. Note: Tank T-121 was out of service at the time of the inspection.

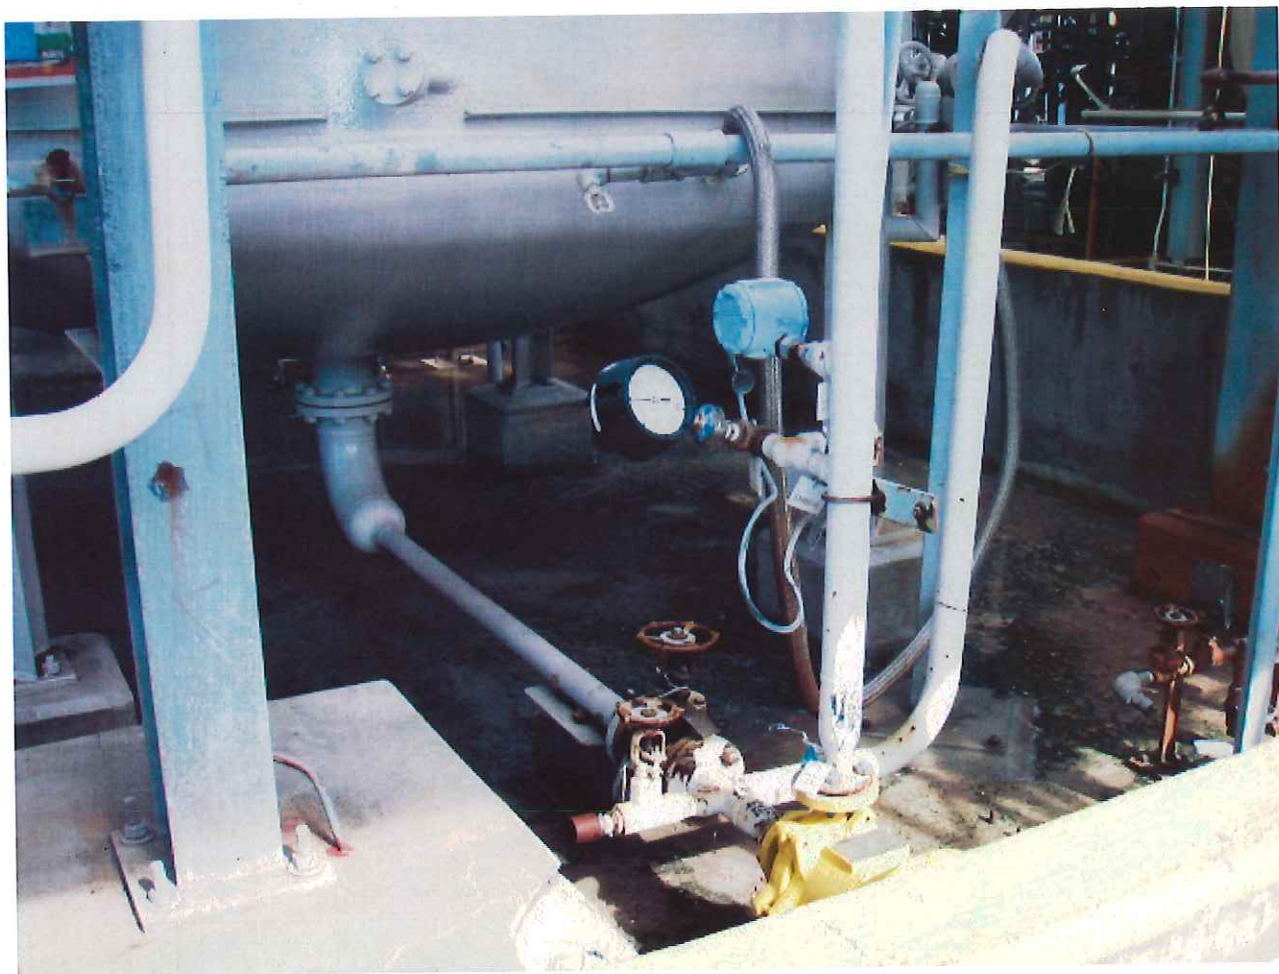
Photo # 6

Photographer: Ryan Rosser	Date: 2/11/09	Time: 1346 Hours
City/County: Plaquemine/ Iberville Parish		State: LA
Location: Dow Chemical Company		
Subject: Secondary containment system flooring for tank T-39. The secondary containment system was constructed of bare concrete.

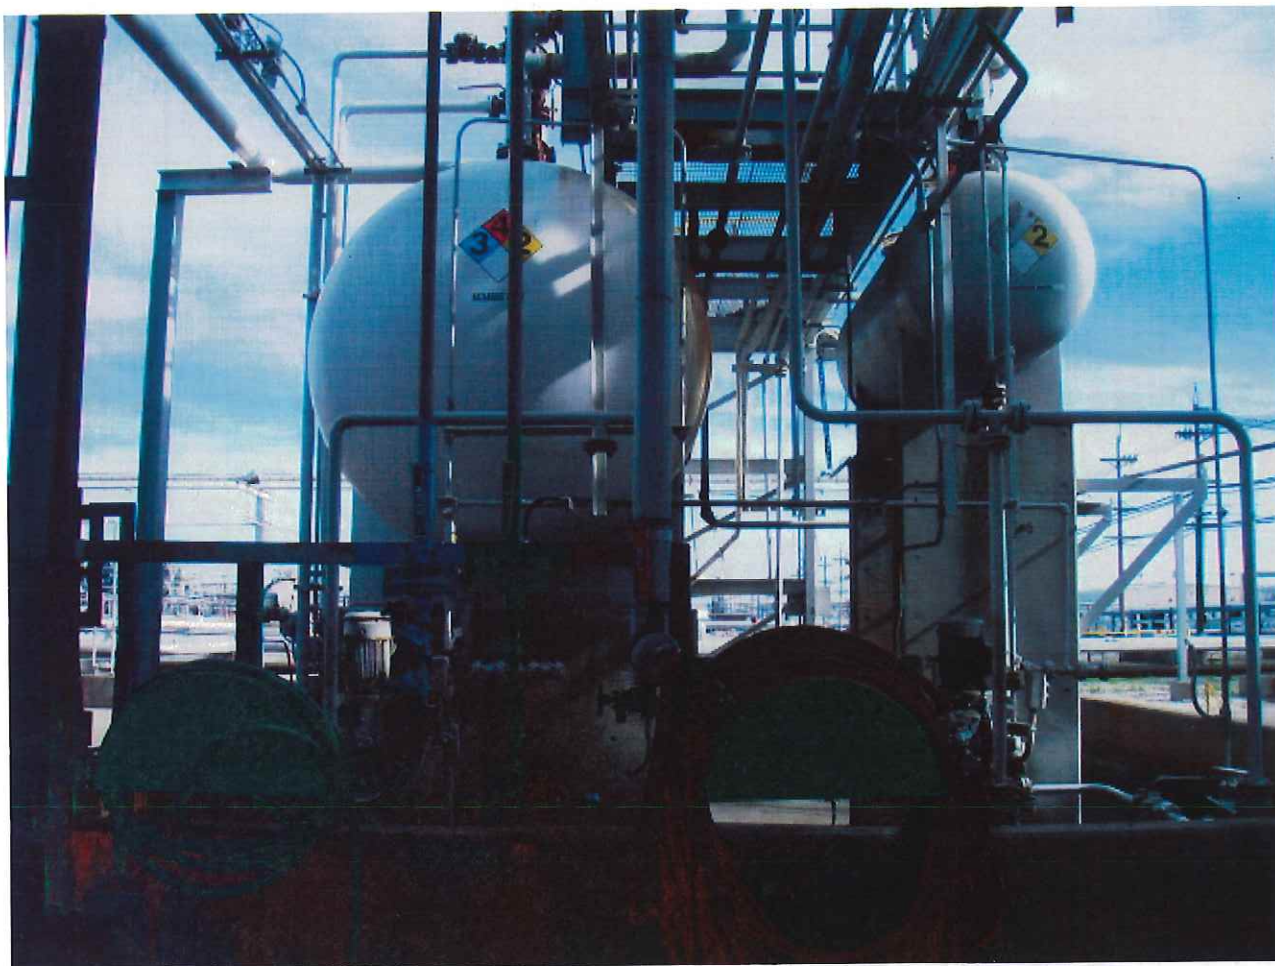
Photo # 7

Next, the Group left tank the Cellulose Plant and arrived at the Methane Plant. The EPA Inspector observed RCRA permitted tanks, D-750 and D-751. Both tanks were horizontal bullet tanks raised above the ground (Photograph #7). Dow personnel stated tanks D-750 and D-751 were used to store methyl fluoride waste, chloroform waste, carbon tet waste, hydrochloric acid waste, sulfuric acid waste, and chlorinated methane waste. Dow personnel further stated tank D-750 has a total capacity of 940 gallons and tank D-751 has a total capacity of 6,018 gallons. The tanks share a secondary containment system constructed of bare concrete. The EPA Inspector

Photographer: Ryan Rosser	Date: 2/11/09	Time: 1453 Hours
City/County: Plaquemine/ Iberville Parish		State: LA
Location: Dow Chemical Company		
Subject: Above ground hazardous waste tanks, D-750 and D-751, located in the facility’s Methane Plant. Tank D-750, pictured on the right, is a RCRA permitted tank with a total capacity of 940 gallons. Tank D-751, pictured on the left, is also a RCRA permitted tank with a total capacity of 6,018 gallons. According to facility personnel, tanks D-750 and D-751 hold methyl fluoride waste, chloroform waste, carbon tetrachloride waste, hydrochloric acid waste, sulfuric acid waste, and chlorinated methane waste. The secondary containment system for tanks D-750 and D-751 was constructed of bare concrete.

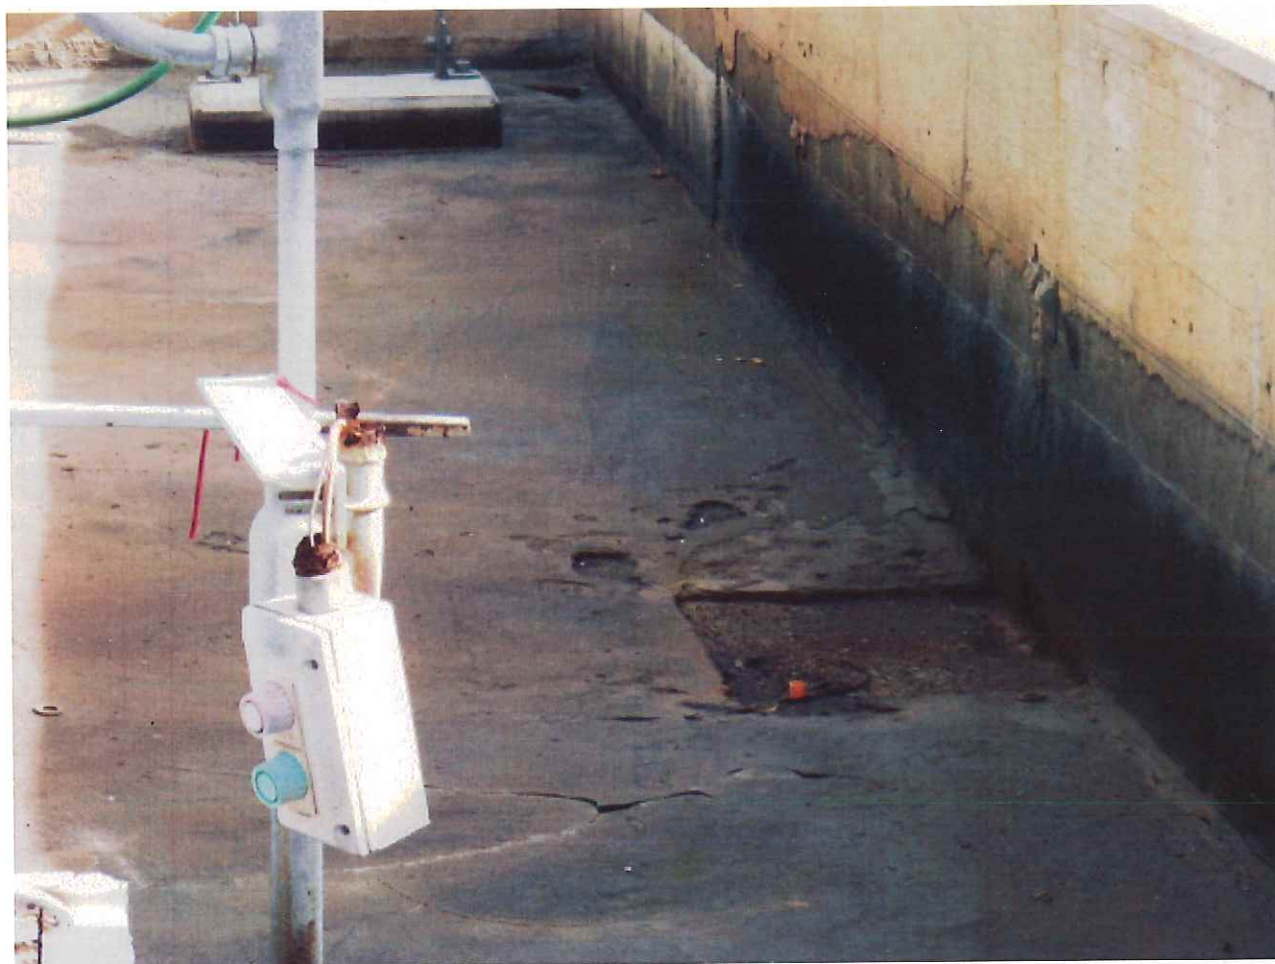
Photo # 8

observed portions of the secondary containment system floor that were cracked and/or weathered (Photograph #8).

- 1.) During the inspection, the EPA Inspector observed cracks in the flooring of the secondary containment system for RCRA permitted tanks D-750 and D-751 located in the Methane Plant. According to 40 CFR 264.193 (e)(1)(iii) – external liner systems must be free of cracks or gaps.

Photographer: Ryan Rosser	Date: 2/11/09	Time: 1454 Hours
City/County: Plaquemine/ Iberville Parish		State: LA
Location: Dow Chemical Company		
Subject: Secondary containment system flooring for RCRA permitted tanks, D-750 and D-751. The secondary containment system was constructed of bare concrete. Note: The flooring had some cracks. According to facility personnel, the small opening in the wall pictured in the lower right portion of the photograph is an underground pipe which empties into a drainage collection system used for collection storm water runoff. On the opposite side of the containment wall is a valve for controlling flow through the opening.

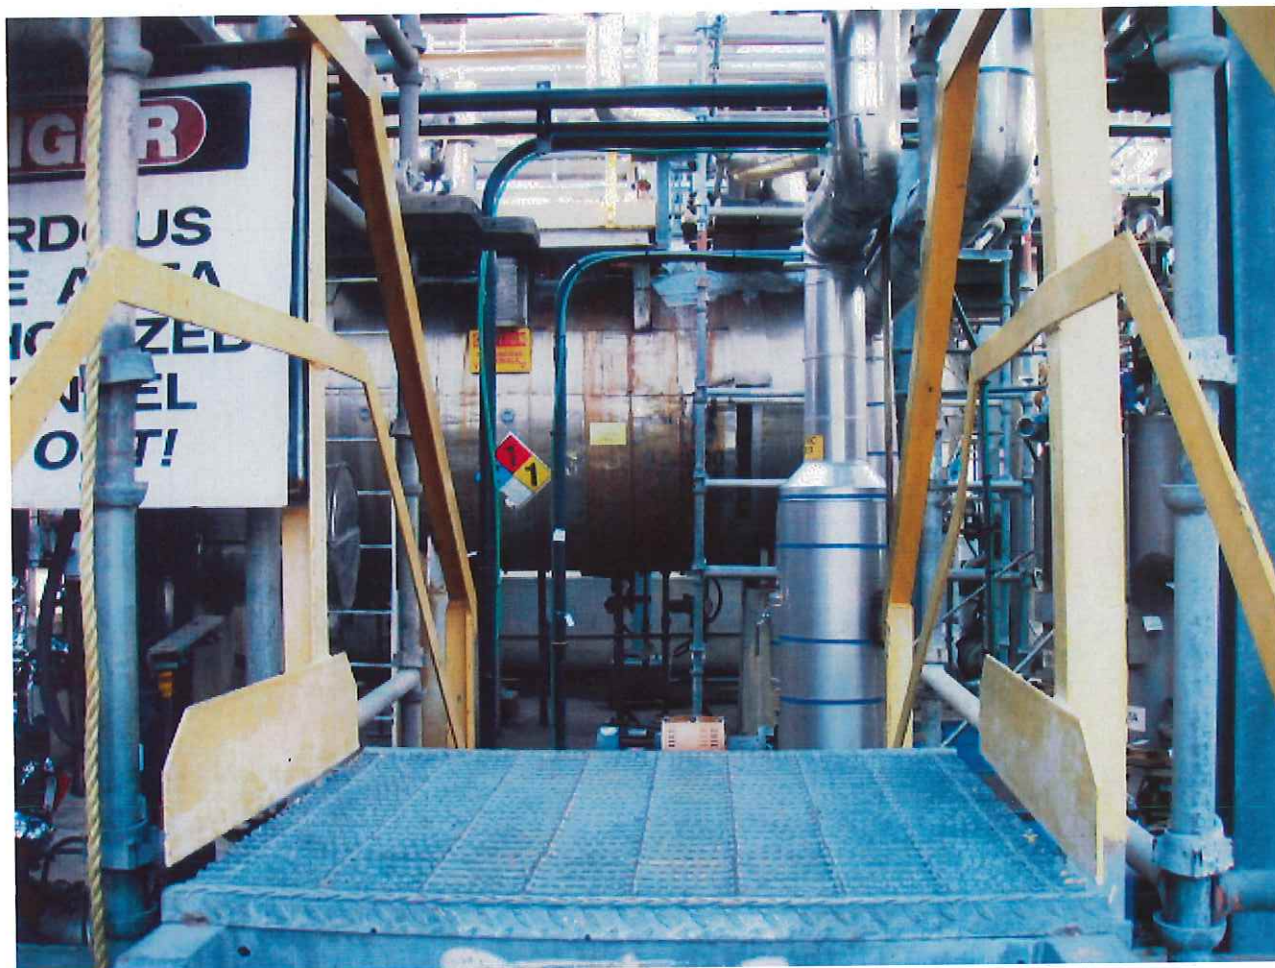
Photo # 9

Photographer: Ryan Rosser	Date: 2/11/09	Time: 1511 Hours
City/County: Plaquemine/ Iberville Parish		State: LA
Location: Dow Chemical Company		
Subject: Above ground hazardous waste tank, D-13, located in the facility's Solvent Plant. Tank D-13 is a RCRA permitted tank and holds 2,500 gallons. According to facility personnel, tank D-13 holds hexachloro compounds waste group. The secondary containment system was constructed of bare concrete.

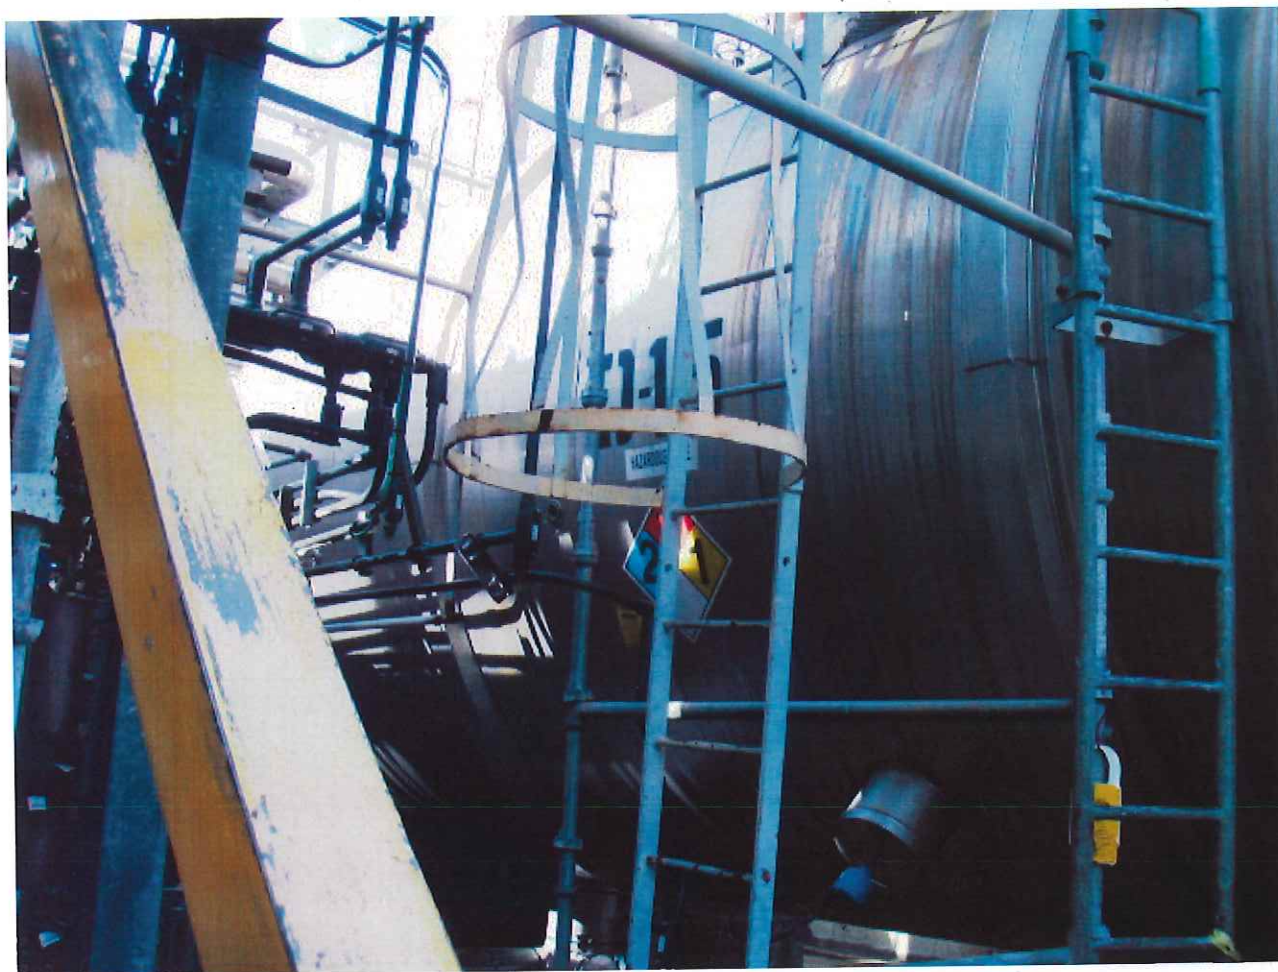
Photo # 10

Photographer: Ryan Rosser	Date: 2/11/09	Time: 1512 Hours
City/County: Plaquemine/ Iberville Parish		State: LA
Location: Dow Chemical Company		
Subject: Above ground hazard waste tank, D-15, located in the facility's Solvent Plant. Tank D-15 is a RCRA permitted tank with a total capacity of 22,670 gallons. According to facility personnel, tank D-15 holds hexachloro compounds waste group. Tank D-15 shares a secondary containment system with tank D-13. The secondary containment system was constructed of bare concrete.

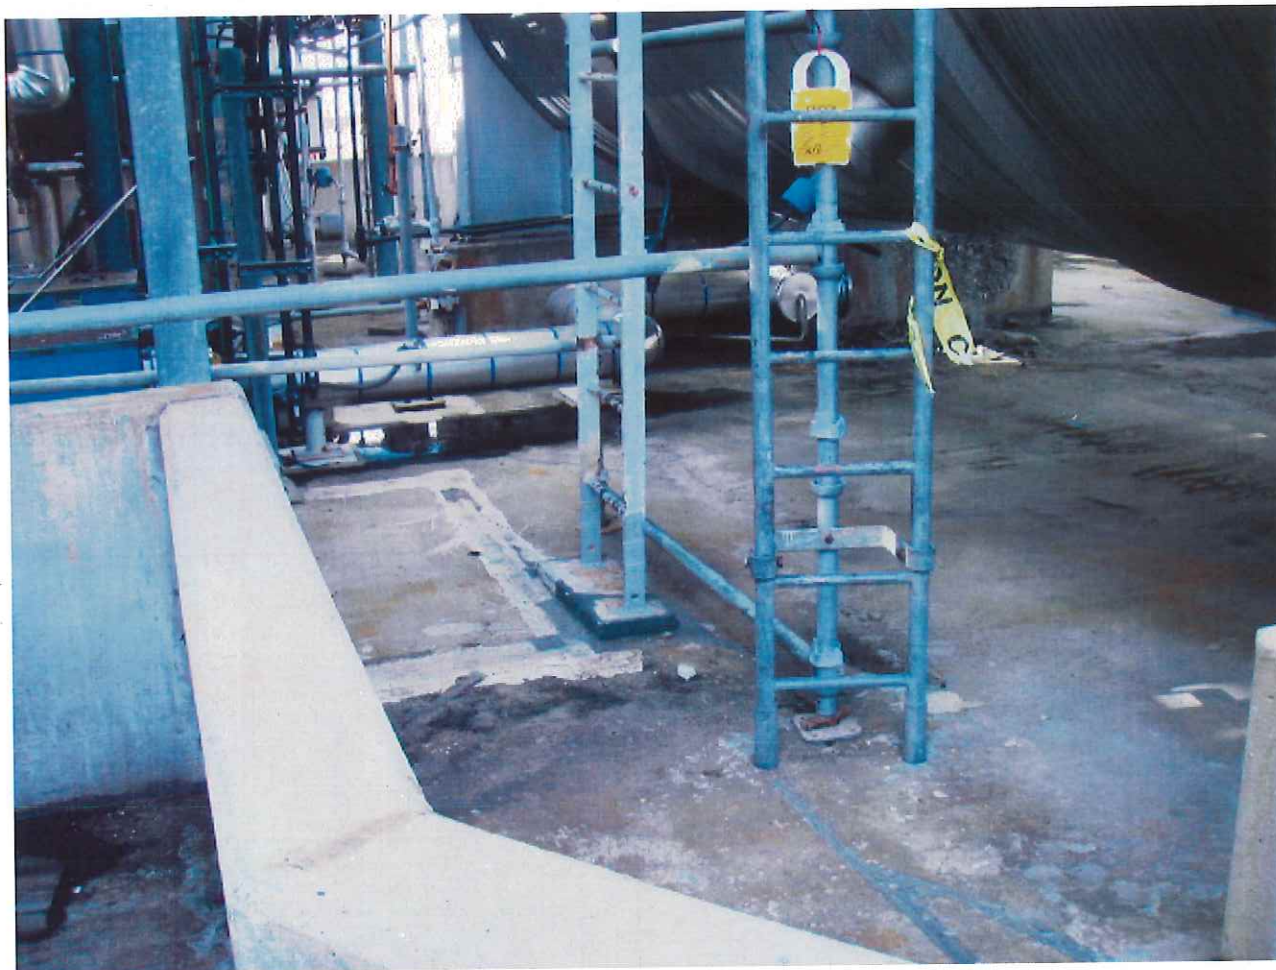
Photo # 11

Photographer: Ryan Rosser	Date: 2/11/09	Time: 1513 Hours
City/County: Plaquemine/ Iberville Parish		State: LA
Location: Dow Chemical Company		
Subject: The secondary containment system for hazardous waste tanks D-13 and D-15 was constructed of bare concrete. The cracks were filled in with an epoxy identified as Semstone® according to an MSDS provided by the facility.

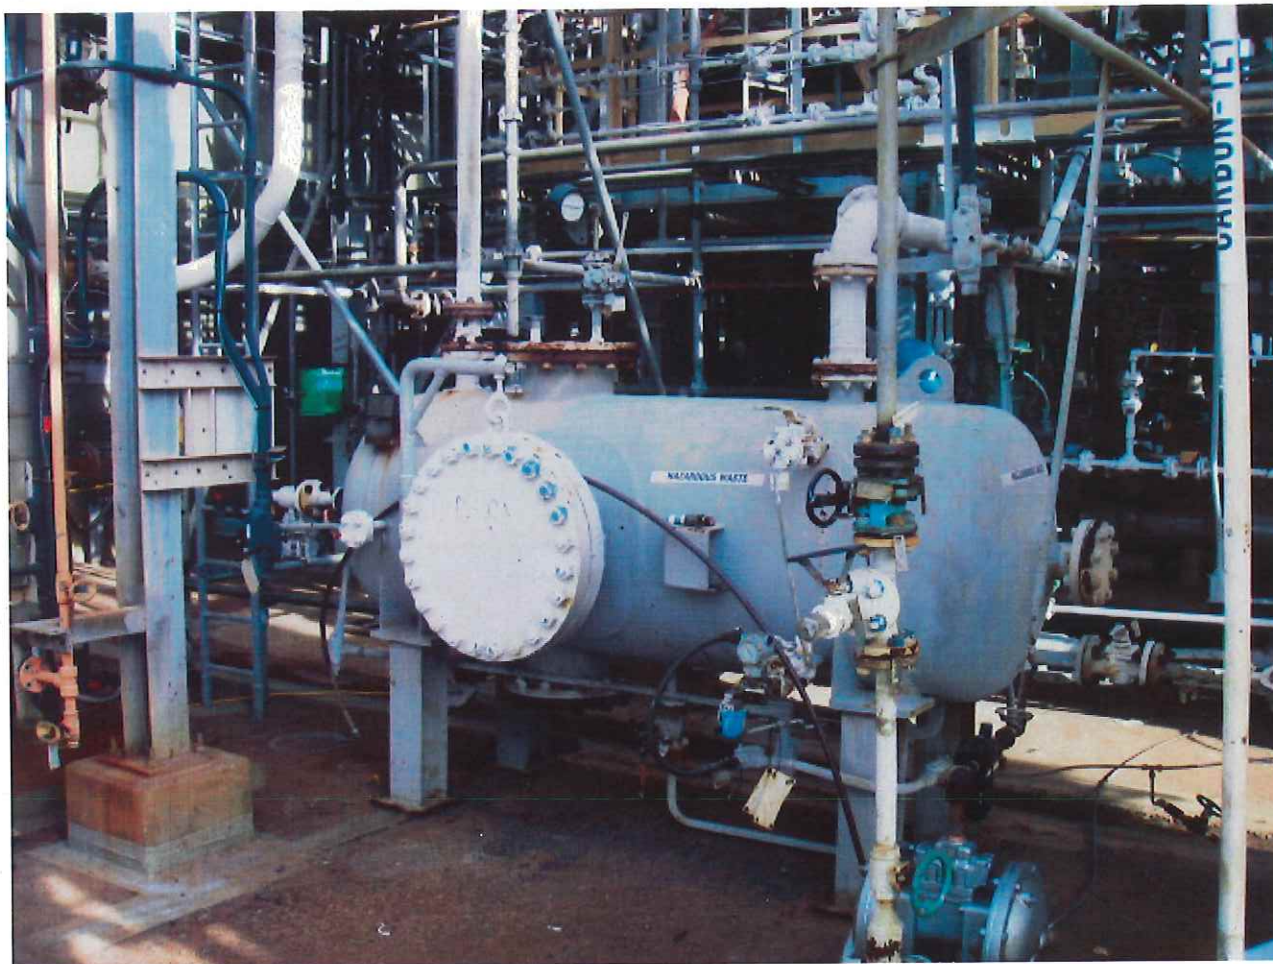
Photo # 12

Photographer: Ryan Rosser	Date: 2/11/09	Time: 1520 Hours
City/County: Plaquemine/ Iberville Parish		State: LA
Location: Dow Chemical Company		
Subject: Above ground hazardous waste tank, D-92-A, located in the facility's Solvents Plant. Tank D-92-A is a RCRA permitted tank with a total capacity of 370 gallons. According to facility personnel, tank D-92-A holds carbon tetrachloride waste, and perchloroethylene waste. Tank D-92-A shares a secondary containment system with tank D-42. The secondary containment system was constructed of bare concrete.

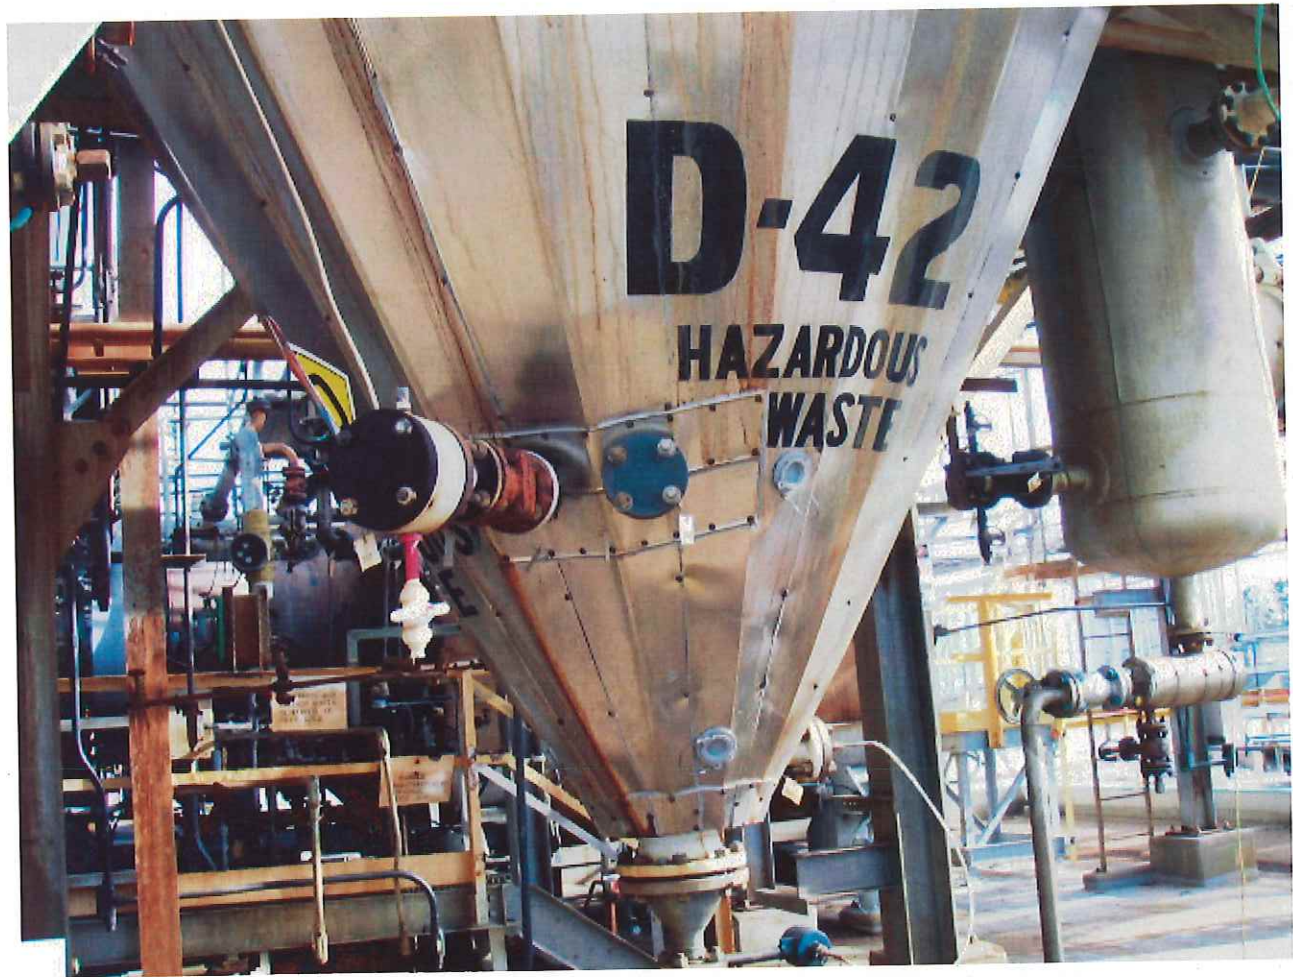
Photo # 13

Photographer: Ryan Rosser	Date: 2/11/09	Time: 1521 Hours
City/County: Plaquemine/ Iberville Parish		State: LA
Location: Dow Chemical Company		
Subject: Hazardous waste tank, D-42, located in the facility's Solvent Plant. Tank D-42 is a RCRA permitted tank and has a capacity of 2,768 gallons. According to facility personnel, tank D-42 holds multiple wastes including carbon tetrachloride waste. Tank D-42 shares a secondary containment system with hazardous waste tank D-92-A.

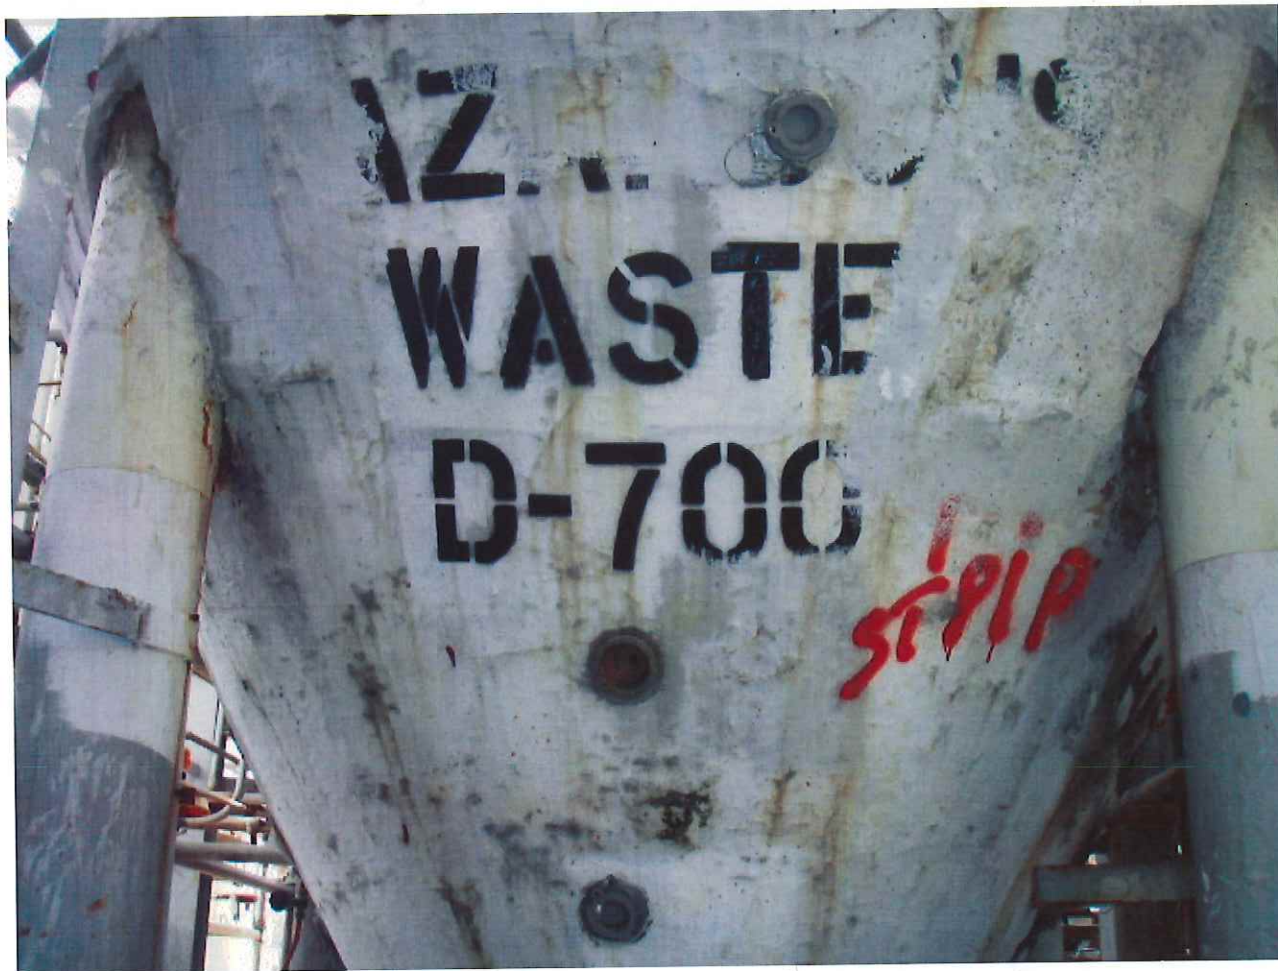
Photo # 15

Photographer: Ryan Rosser	Date: 2/11/09	Time: 1531 Hours
City/County: Plaquemine/ Iberville Parish		State: LA
Location: Dow Chemical Company		
Subject: Hazardous waste tank, D-700, located in the facility's Solvent Plant. Tank D-700 is a RCRA permitted tank with a total capacity of 4,800 gallons. According to facility personnel, tank D-700 holds carbon tetrachloride waste, trichloroethane waste, and other wastes. Tank D-700 shares the secondary containment system with tanks D-92-A, D-42, and D-701.

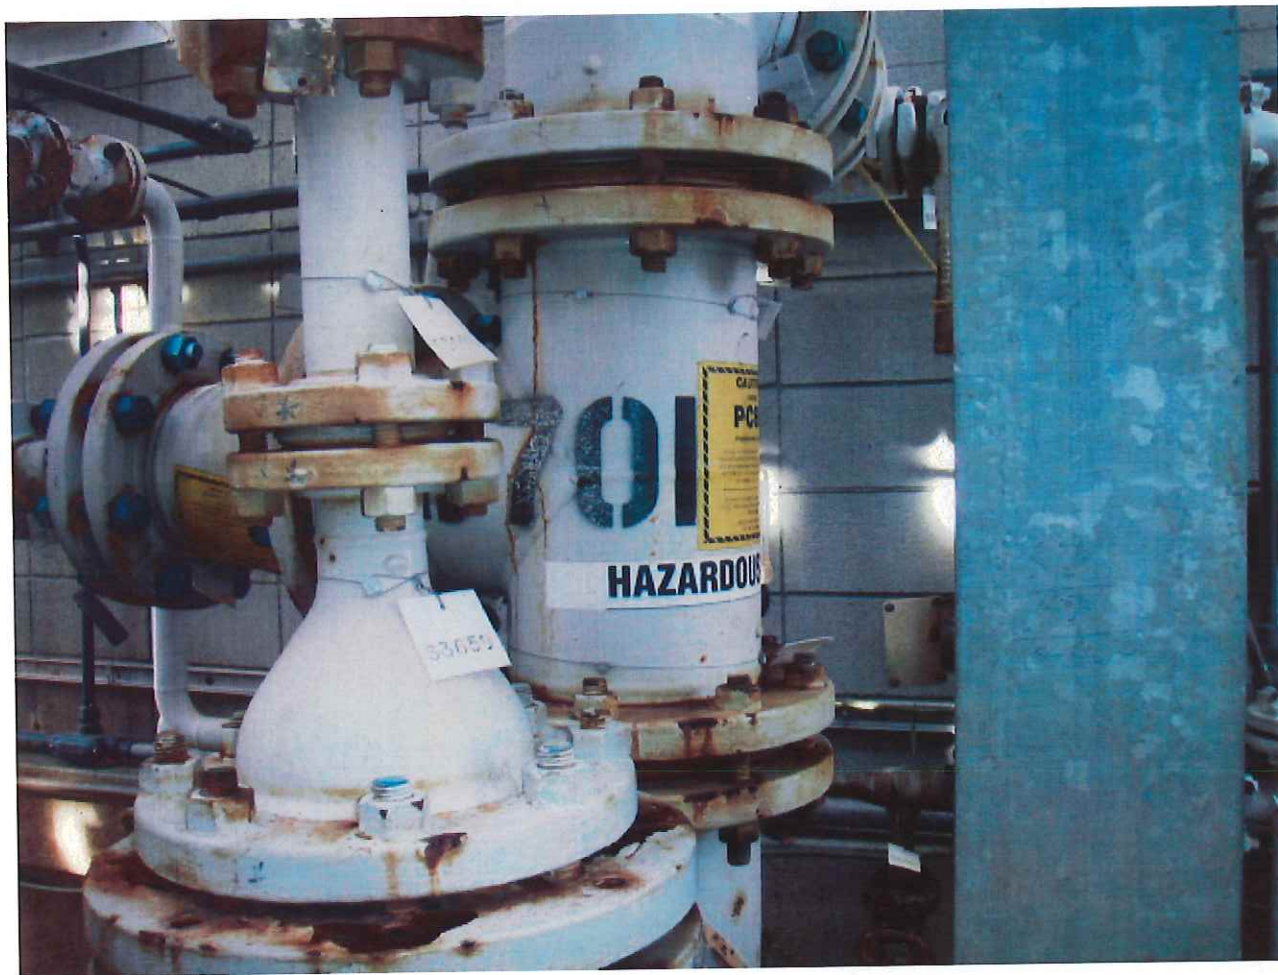
Photo # 16

Photographer: Ryan Rosser	Date: 2/11/09	Time: 1532 Hours
City/County: Plaquemine/ Iberville Parish		State: LA
Location: Dow Chemical Company		
Subject: Hazardous waste tank, D-701, located in the facility's Solvent Plant. Facility personnel stated they have requested the Louisiana Department of Environmental Quality (LDEQ) remove tank D-701 from their RCRA permit because they believe it is not a tank. Tank D-701 has a total capacity of 50 gallons and shares a secondary containment system with tanks, D-92-A, D-42, and D-700.

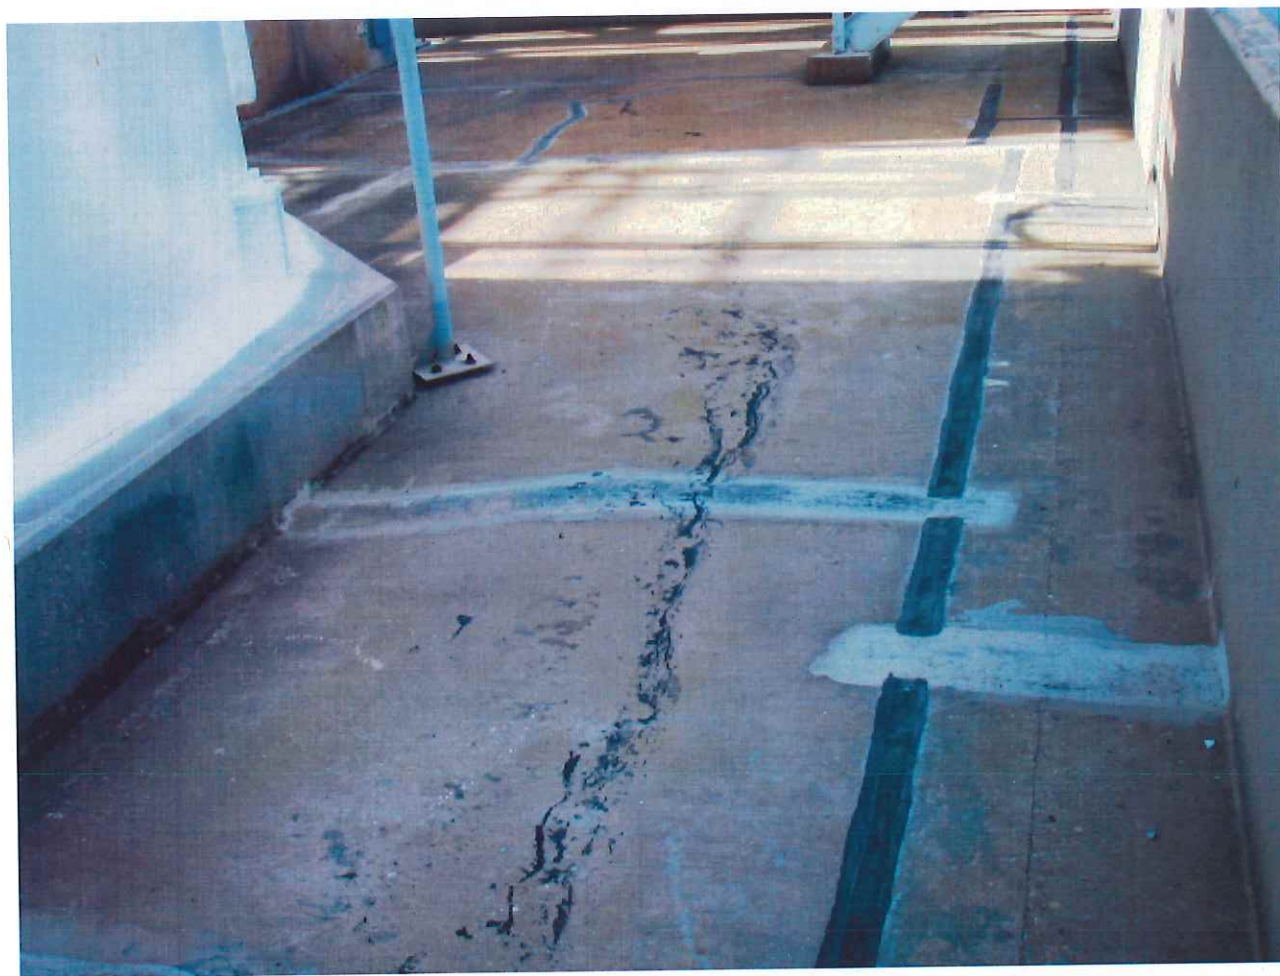
Photo # 19

Photographer: Ryan Rosser	Date: 2/12/09	Time: 0942 Hours
City/County: Plaquemine/ Iberville Parish		State: LA
Location: Dow Chemical Company		
Subject: Secondary containment system flooring located adjacent to tank T-400-2. The secondary containment system was constructed of bare concrete. Cracks were filled in with an epoxy identified as Semstone® according to an MSDS provided by the facility.

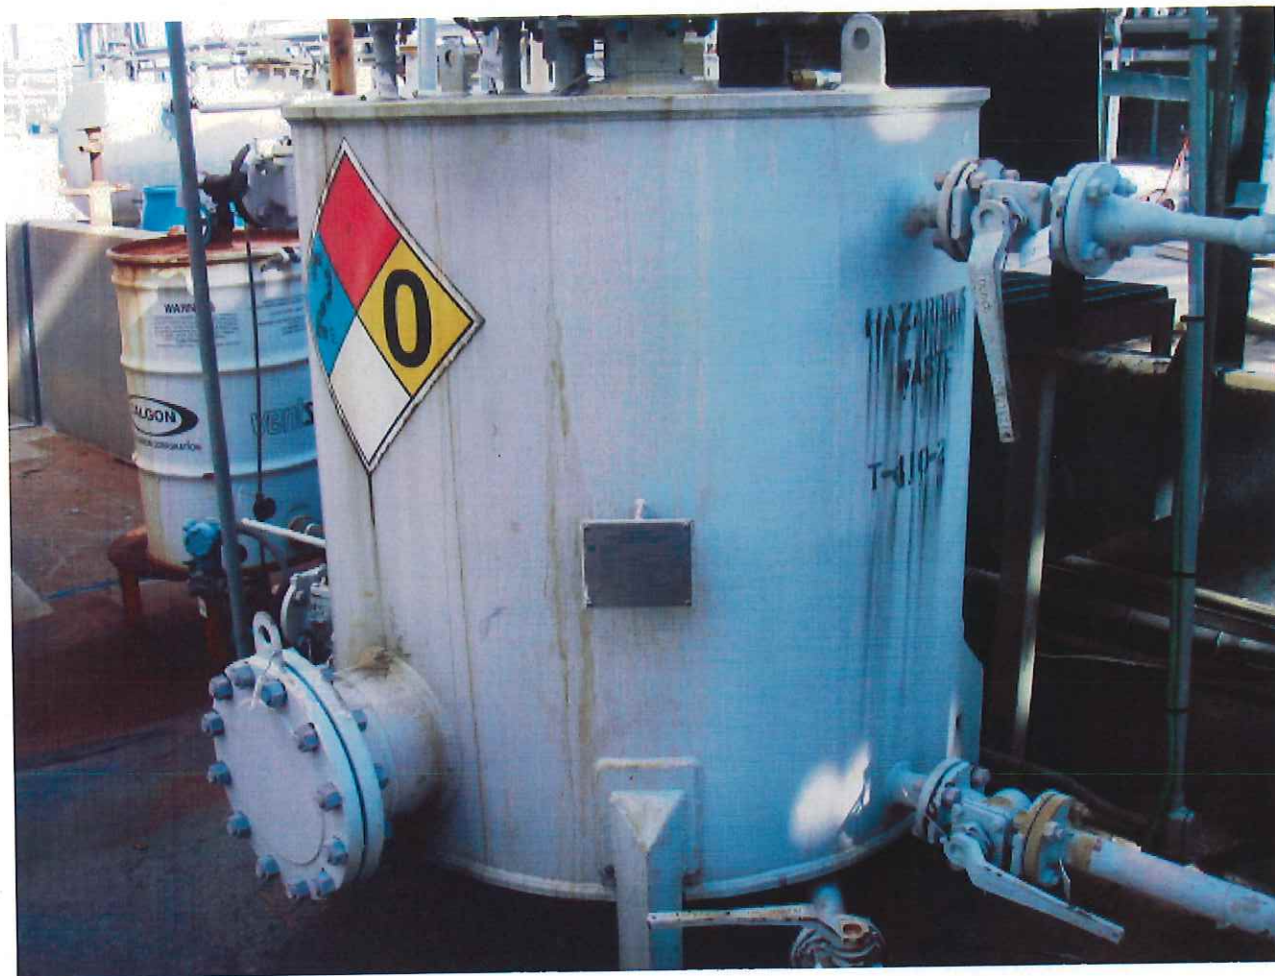
Photo # 20

Photographer: Ryan Rosser	Date: 2/12/09	Time: 0943 Hours
City/County: Plaquemine/ Iberville Parish		State: LA
Location: Dow Chemical Company		
Subject: Above ground hazardous waste tank, T-410-2, located in the facility's Vinyl 2 Plant. Tank T-410-2 is a RCRA permitted tank with a total capacity of 375 gallons. According to facility personnel, tank T-410-2 holds liquid wastes. Tank T-410-2 shares a secondary containment system with tank T-400-2.
